Variable KV Power Supply Construction Notes

By Vaughn P. McDowell

The purpose is to document and refurbish my ten year old variable HV power supply used to power up my 300KV mini- Marx generators. Most of my newer designs use the TL 494 controller; this one uses the NE555 and TL082 op AMP . The refurbishment procedure is not to change the basic design but to simply clean up the controller board and HV section and simplify some of the redundant components. This has been a very handy HVPS which I wish to fortify.

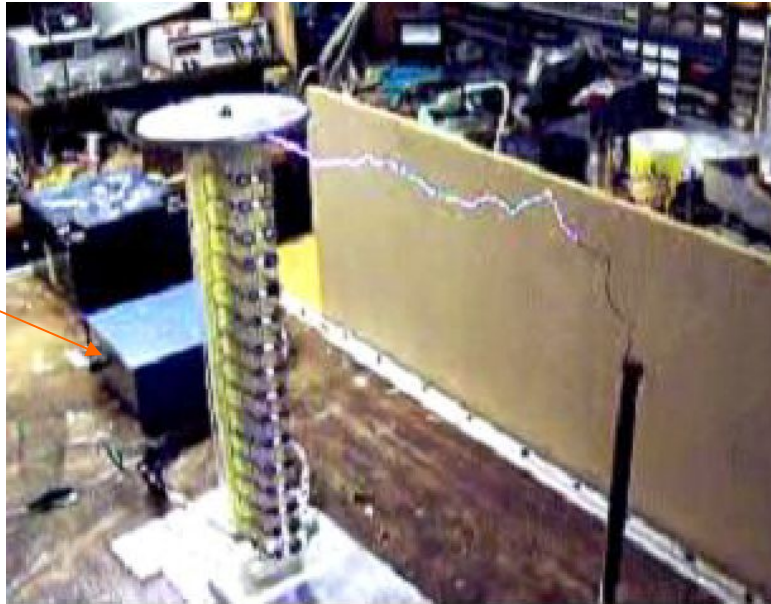
My old general purpose
variable HVPS

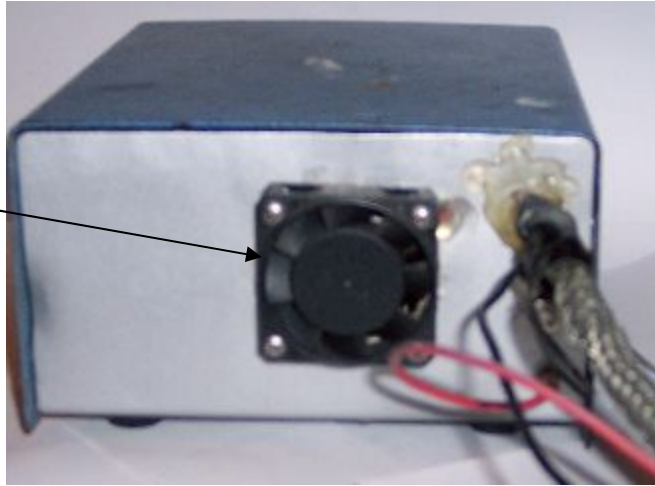
Rear View

12 Volt IGBT cooling fan

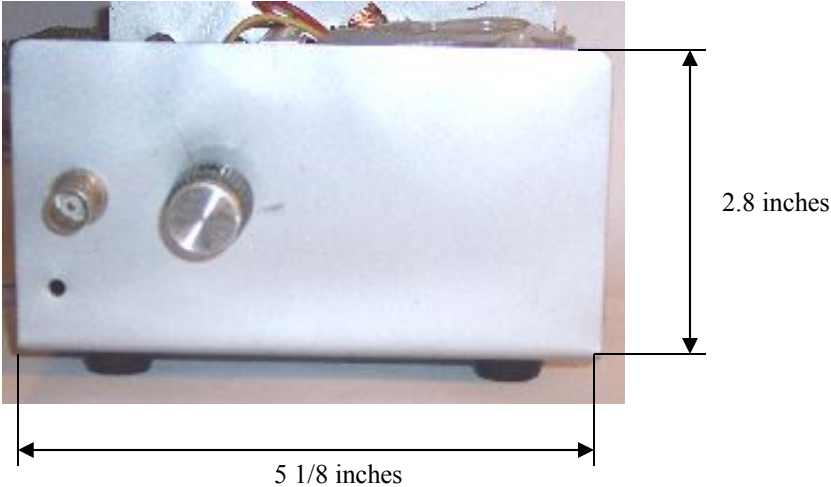
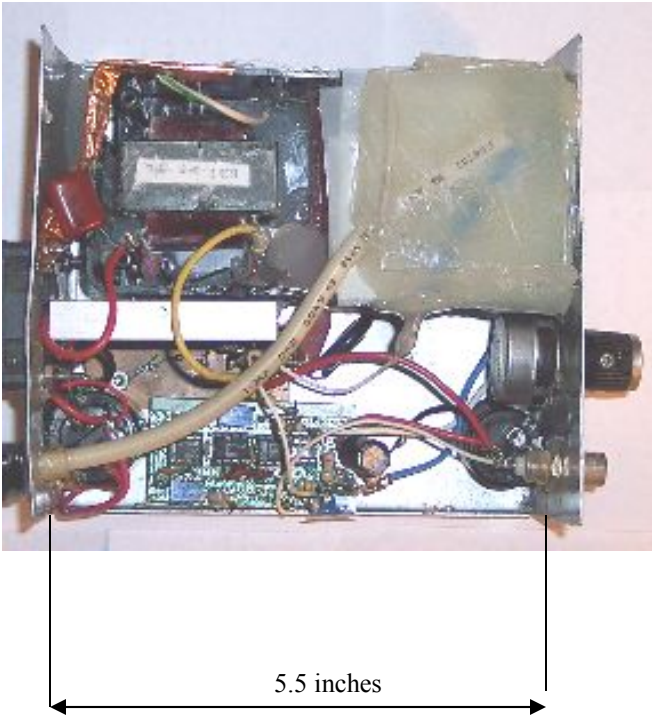
Construction Note 20KV HVPS UNIT \ Some Physical Outside Dimensions

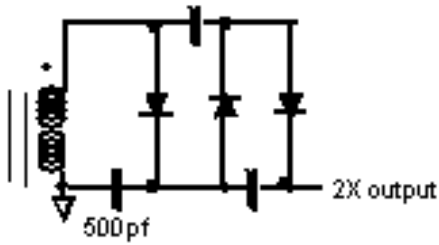
Voltage Multiplier:

Ex. Capacitor Philips Series DD High Voltage Disc Ceramic Type DD60-102 1000pf @ 6KV; two ea connected in series

Ex. Diode = 20 UZ1007 connected in series
